**BLUE OAK ASSESSMENT  
DISC GOLF COURSE DESIGN REVIEW AND  
BLUE OAK MANAGEMENT GUIDELINES**

**Prepared for  
THE CITY OF CHICO**

**Prepared by  
TREE ASSOCIATES  
John M. Lichter, M.S.**

**November 18, 2005**

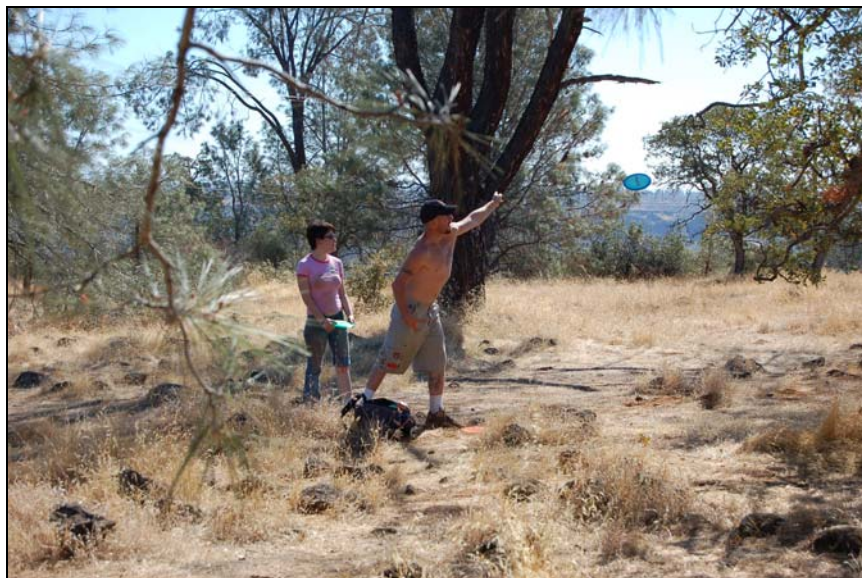
Figure 1. Disc golfers playing short course.

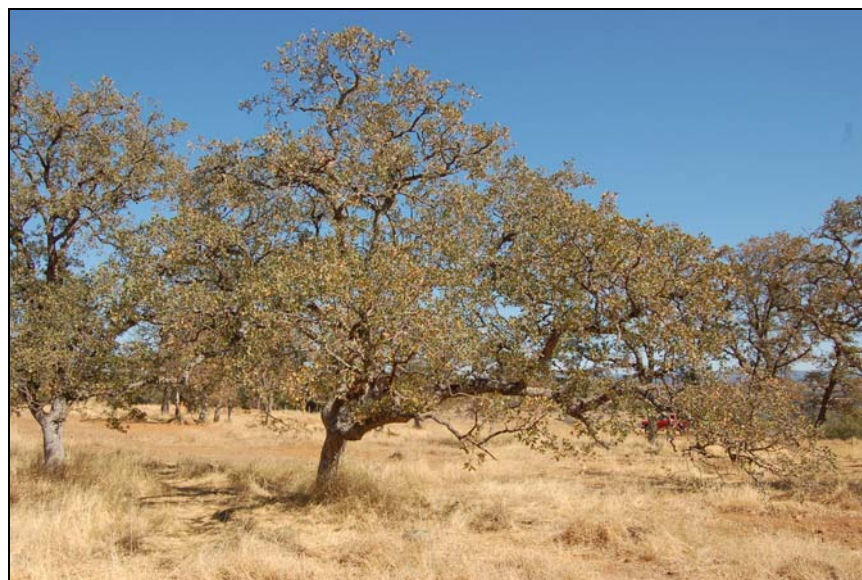
Figure 2. Tree in fair/good health on short course.

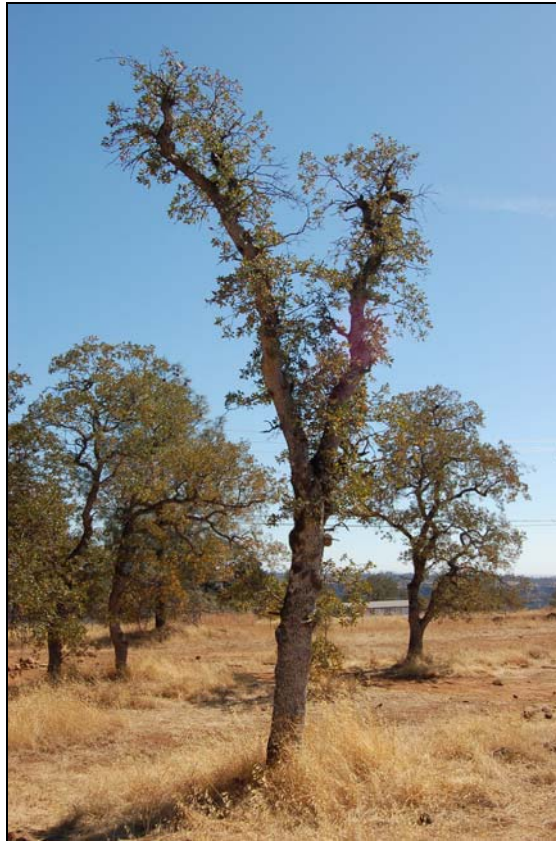
Figure 3. Tree in poor condition on short course; note poor growth rate and epicormic sprouts (low vigor twigs on main trunk).
